INTERVENTION IN THE CONTINUUM:
AN ADAPTIVE USE PLAN FOR THE PSFS BUILDING
ON WASHINGTON SQUARE

A THESIS

Historic Preservation and Architecture

2001

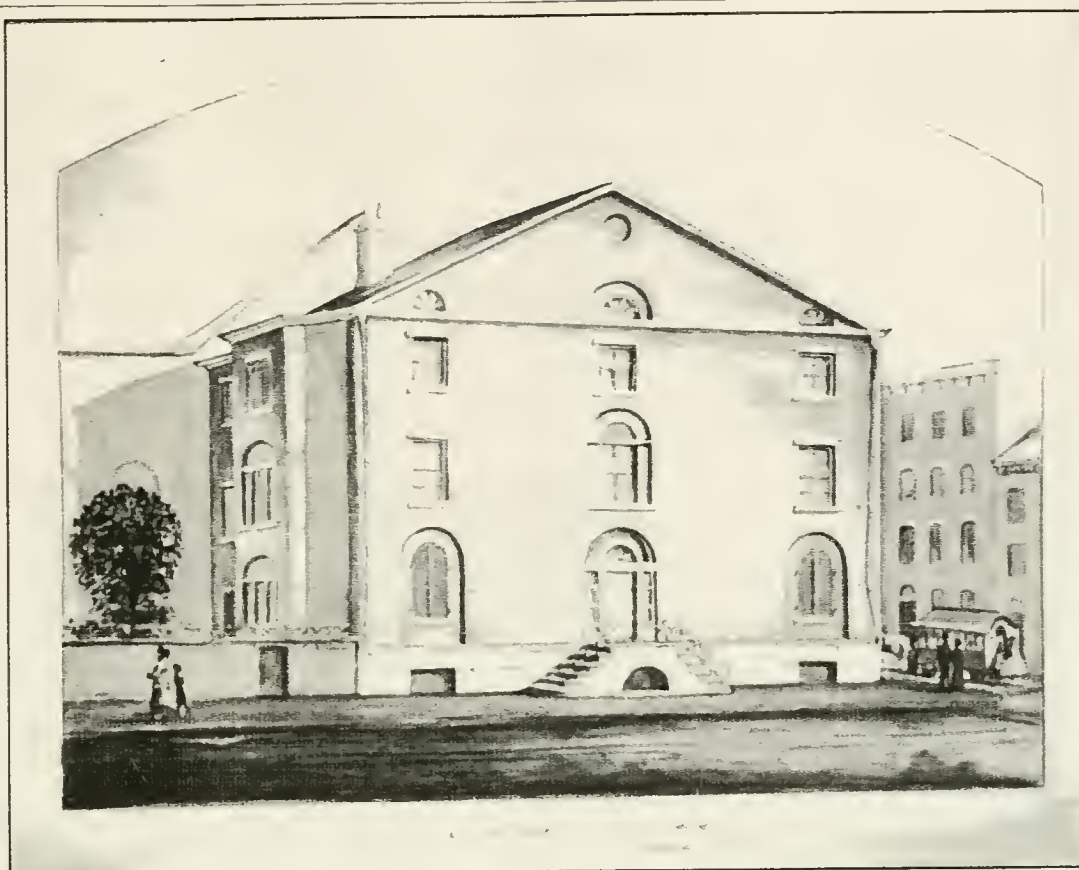
Figure 33. E.H. Klemroth, "SW corner Washington Square and Walnut Street, March 14, 1868" [nb: image was completed either just before or just after demolition of mansion, as the cornerstone was laid 13 June 1868], watercolor.

An E.H. Klemroth watercolor (see Figure 33) in the Castner Collection at the Free Library of Philadelphia¹¹⁰ appears to match the Mills drawing, especially the back bay not found in any other views of the property. The fenestration and courses are all strikingly similar. With this information, it seems clear to assume that Robert Mills designed the Randall Mansion.

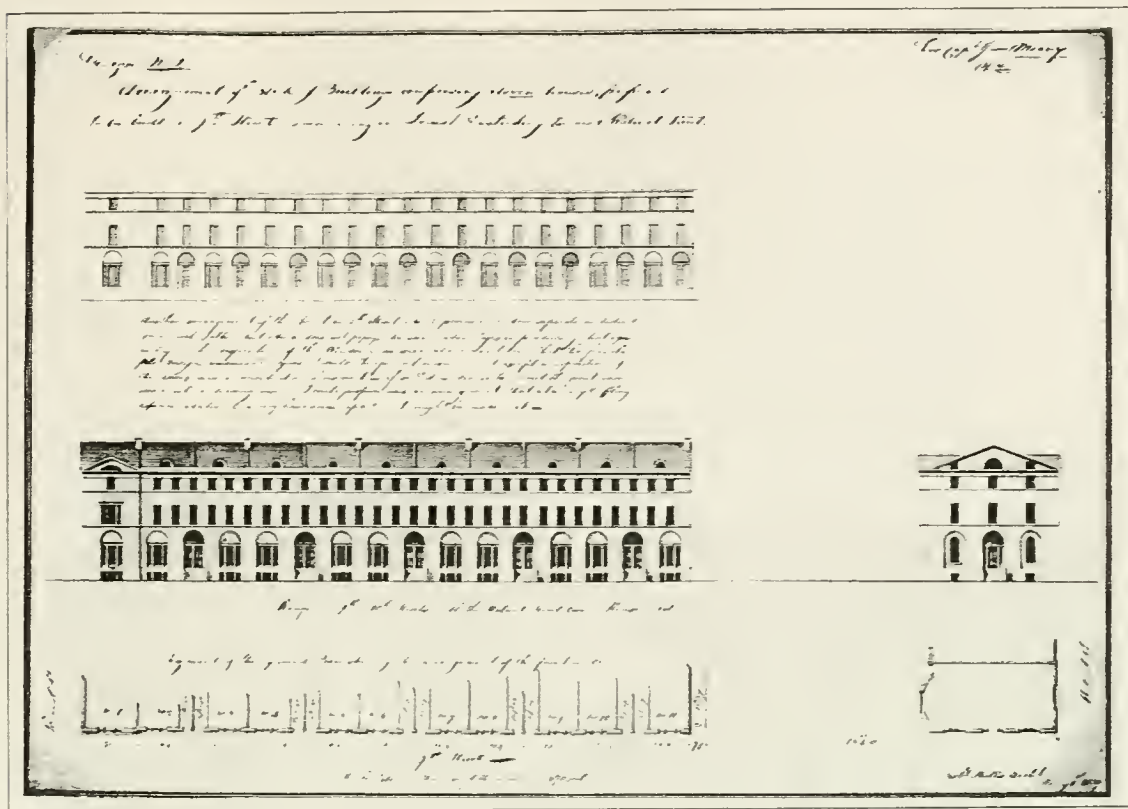
Figure 35. Robert Mills, full drawing and detail: "Design No 2 (Franklin Row) ... for Capt John Meany," drawing, dated 1 May 1809.

Randall Mansion.¹⁰⁸ The orientation of the site –the southwest corner of Walnut Street and a cross street – applies to the site north of Franklin Row as well as to the site for Meany's house. The drawing notes "Walnut St." to the north of the house and a wall extends from the house to the "Alley;" the noted depth of the lot is 154.0 ft rather than 174 feet found in the Randall Mansion lot. The house elevation drawing contains similar architectural elements and aligns with the row house elevations on the left, but was not part of the row. The house plan to the right sides on Walnut, but Franklin Row did not extend all the way to Walnut Street. The end house design on this drawing may have been a record of the Meany home at Walnut and Seventh Streets (and quite similar, as Ames notes, to the John Soane cottage design¹⁰⁹) which influenced the design of Franklin Row.

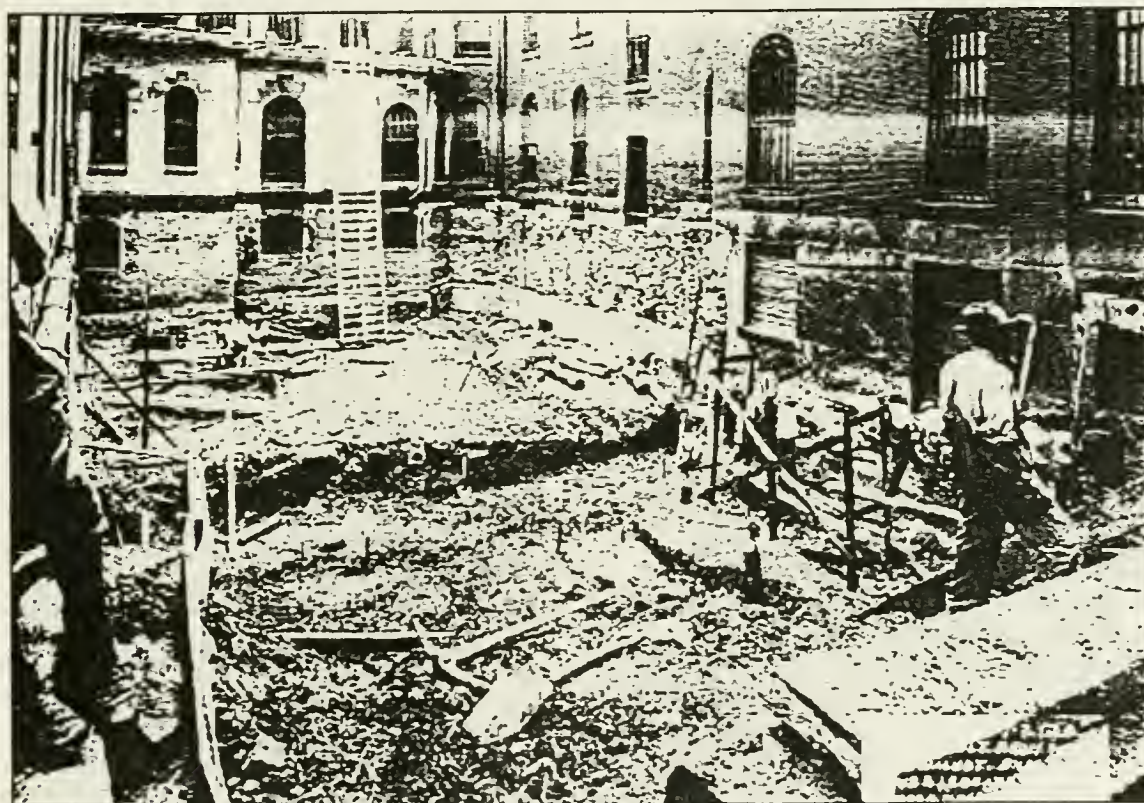
Figure 81. North view of courtyard, foundation walls of building phases visible, 8 July 1930 photograph.

- Figure 80 Excavation of courtyard for vault room construction, 17 June 1930 photograph, Pictorial Collections, Hagley Museum and Library.
- Figure 81 North view of courtyard, foundation walls of building phases visible, 2 July 1930 photograph, Pictorial Collections, Hagley Museum and Library.

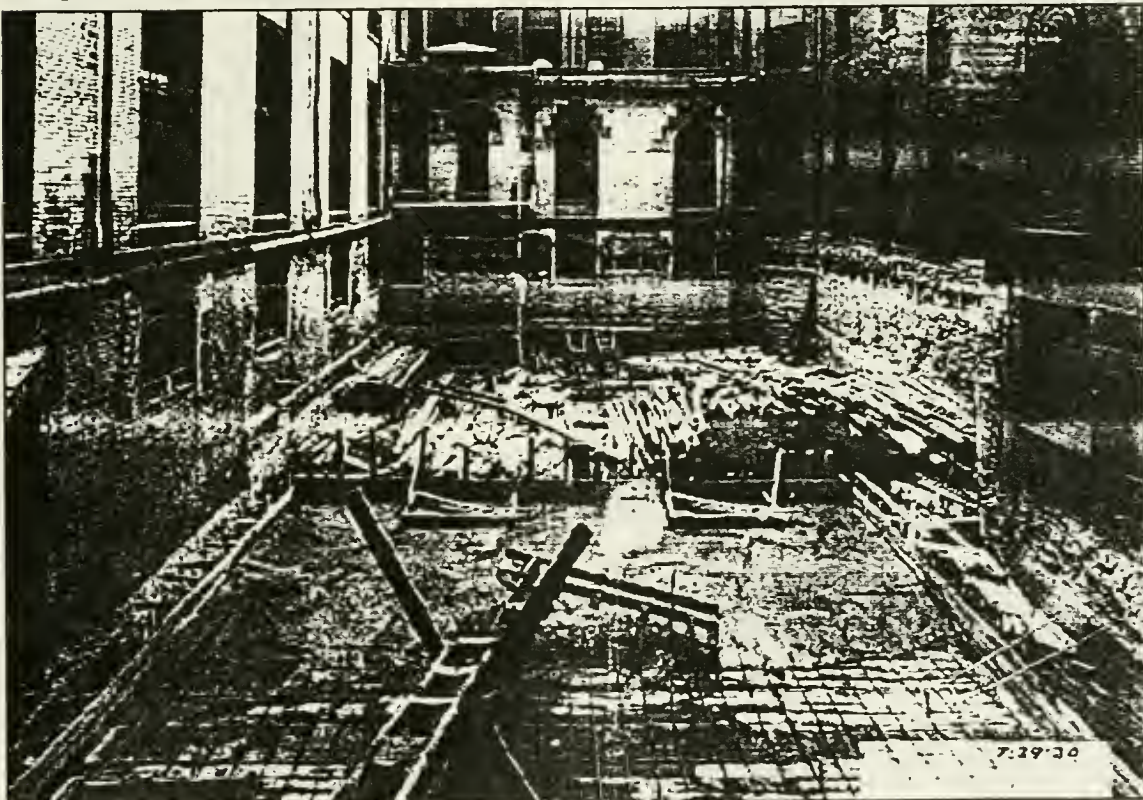
Figure 83. Vault room floor installation, 29 July 1930 photograph.

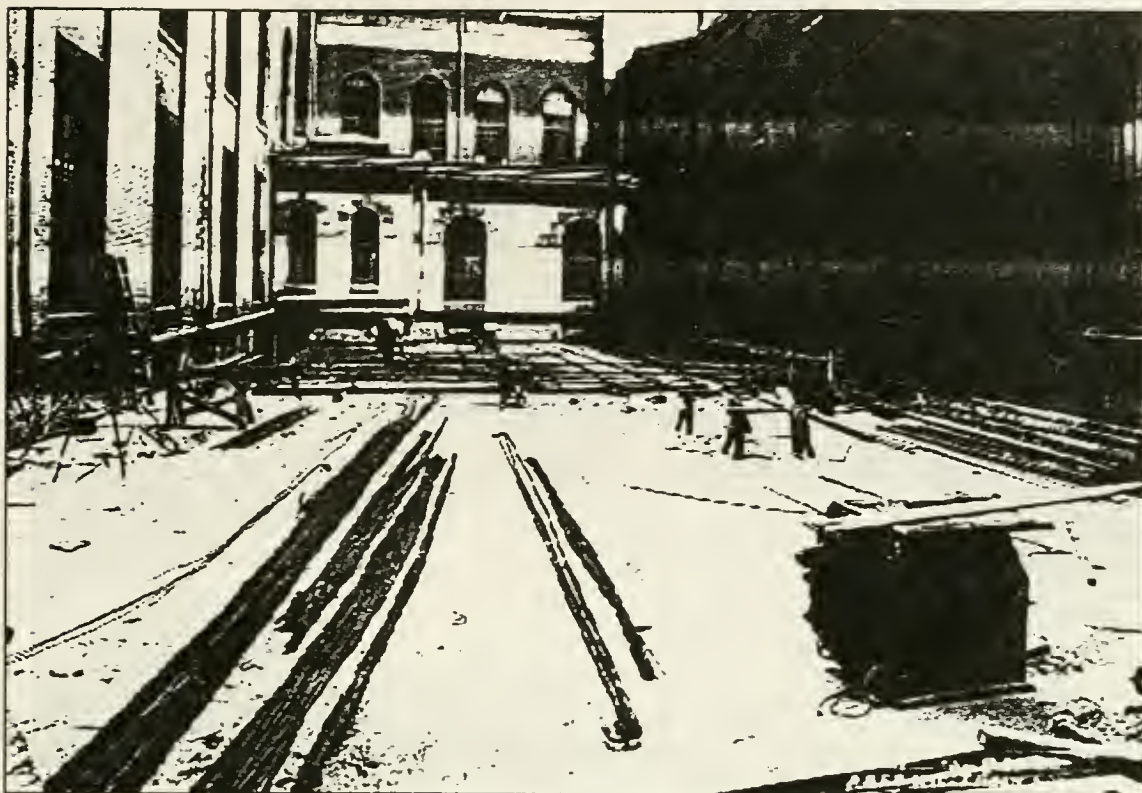
Figure 84. Vault room ceiling installation, 29 August 1930 photograph.

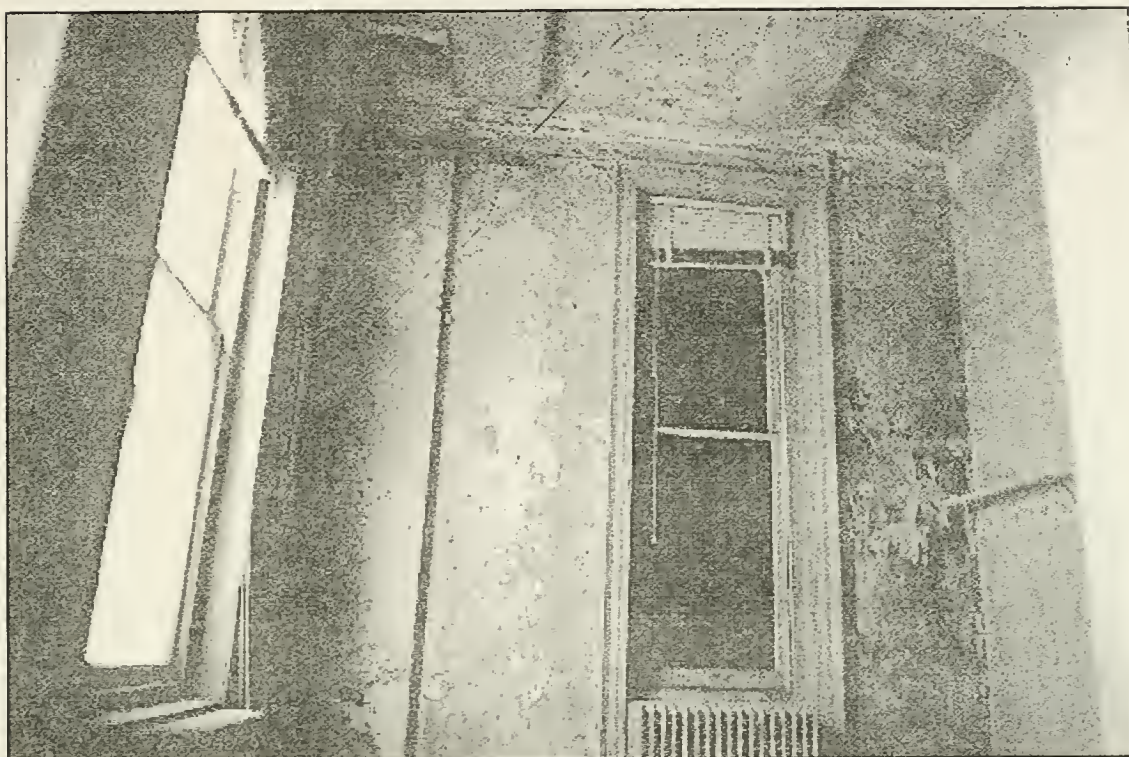
Figure 132. Moisture infiltration deterioration in East wing, November 2000 photograph.

- Figure 132 Moisture infiltration deterioration in East wing, November 2000 photograph.

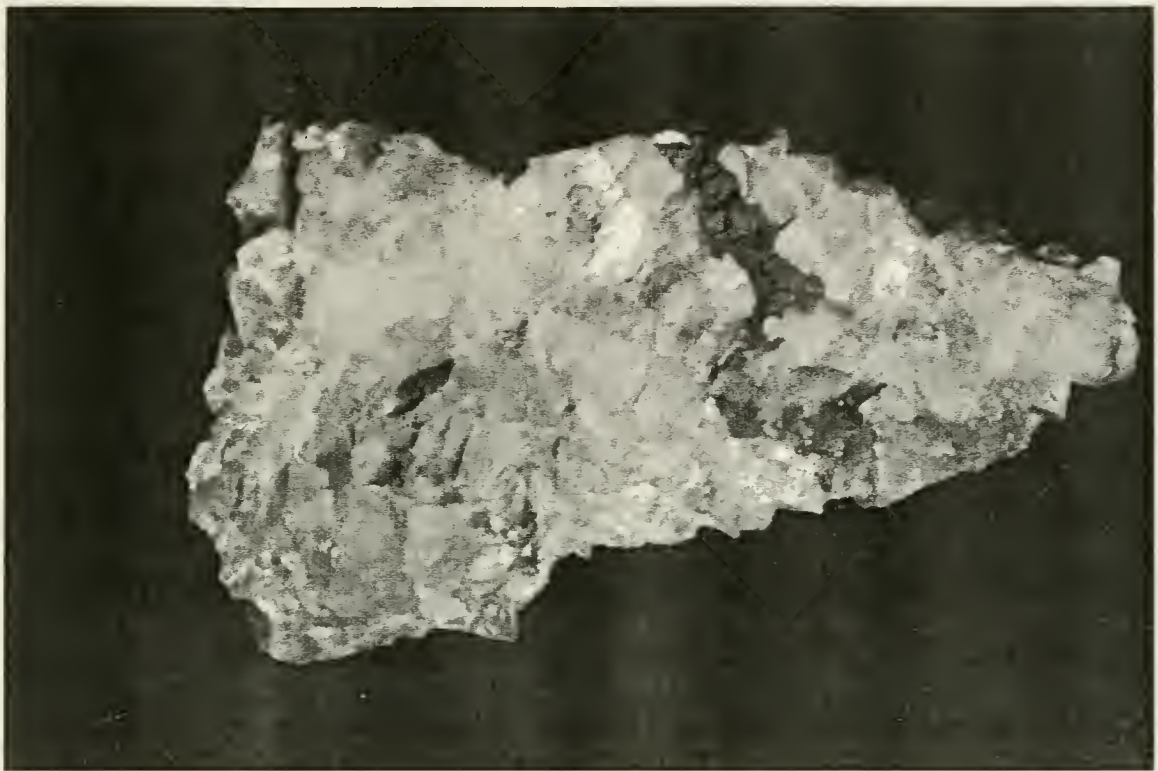
Figure 1. Sample 1, reflected light, 2.5x magnification.
Note clear quartz, milky white feldspar, and dark mineral.

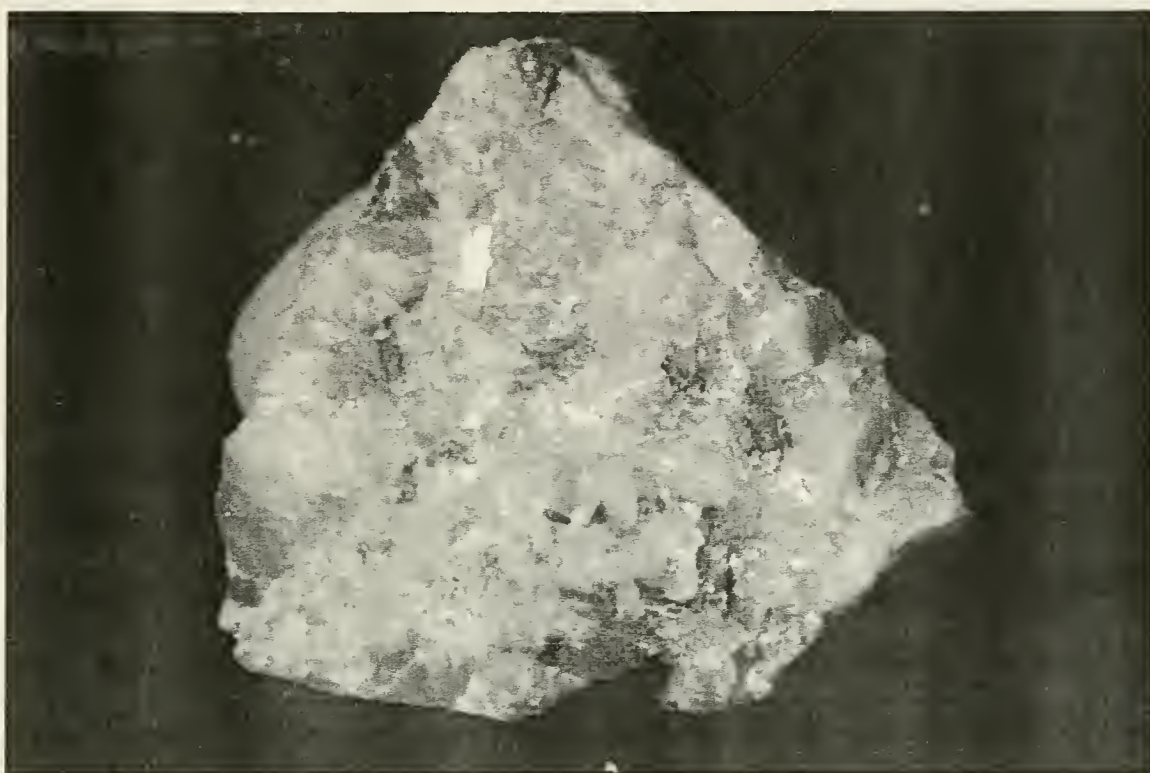
Figure 5. Sample 2, reflected light, 2.5x magnification.
Note milky white to gray feldspar and possibility of muscovite (silvery) and staining.

- Figure 142 (*Appendix VII, figure 5*) Granite sample 2, reflected light, 2.5x magnification. Note milky white to gray feldspar and possibility of muscovite (silvery) and staining.

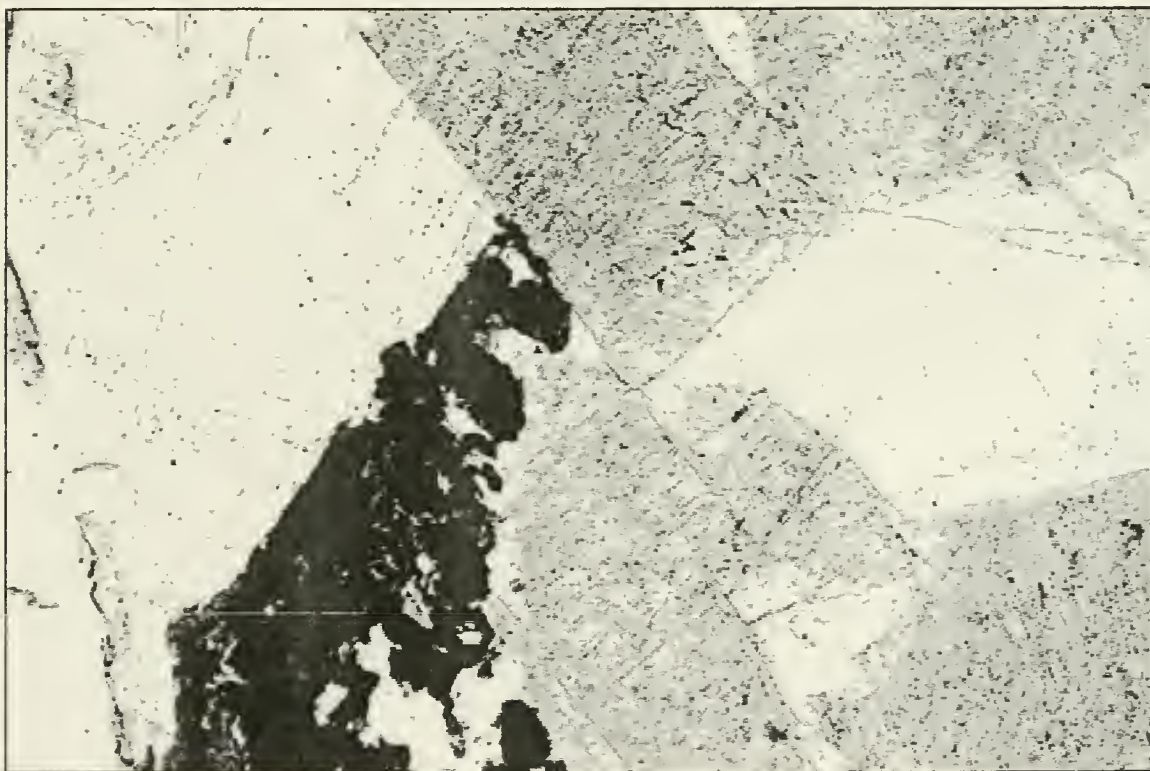
Figure 6. Sample 2, transmitted light, 12.5x magnification.
Note opacity within dark minerals, which might indicate inclusions of metallic content.

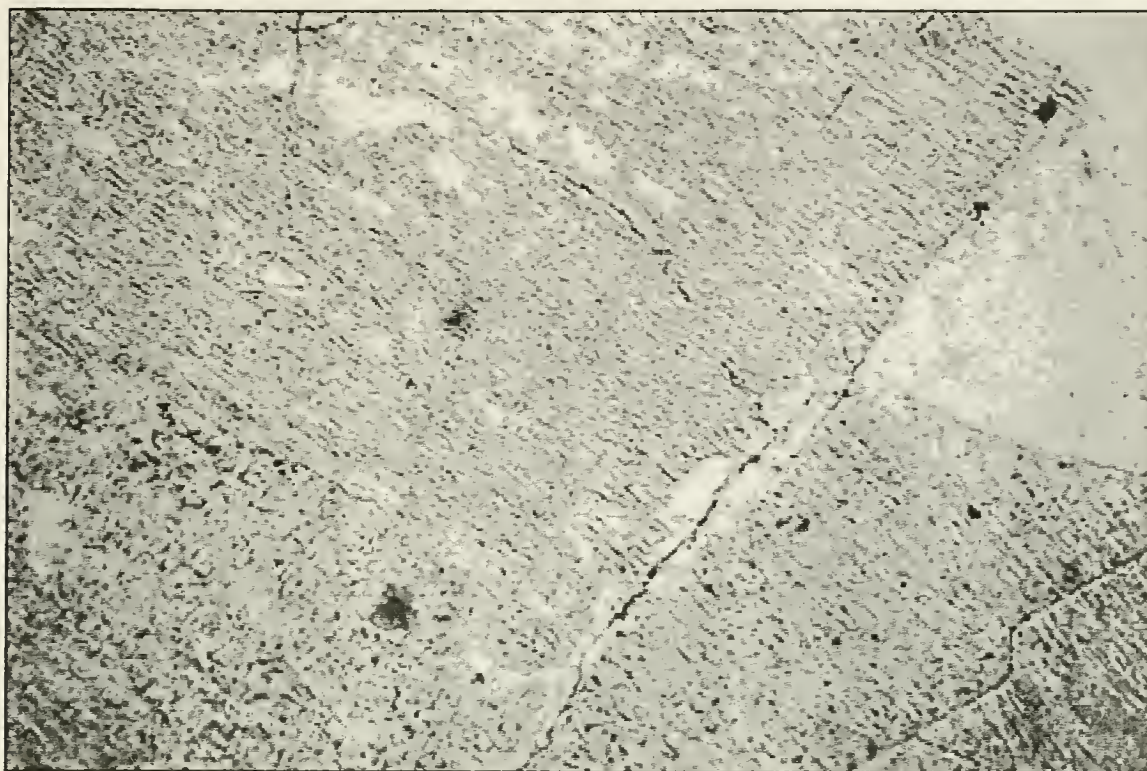
Figure 9. Sample 2, plane-polarized light, 12.5x magnification.
"Rust" along boundaries affiliated with discoloration in hand sample.

- Figure 145 (*Appendix VII, figure 8*) Granite sample 2, cross-polarized light, rotated 45°, 12.5x magnification.
- Figure 146 (*Appendix VII, figure 9*) Granite sample 2, plane-polarized light, 12.5x magnification. "Rust" along boundaries affiliated with discoloration in hand sample.

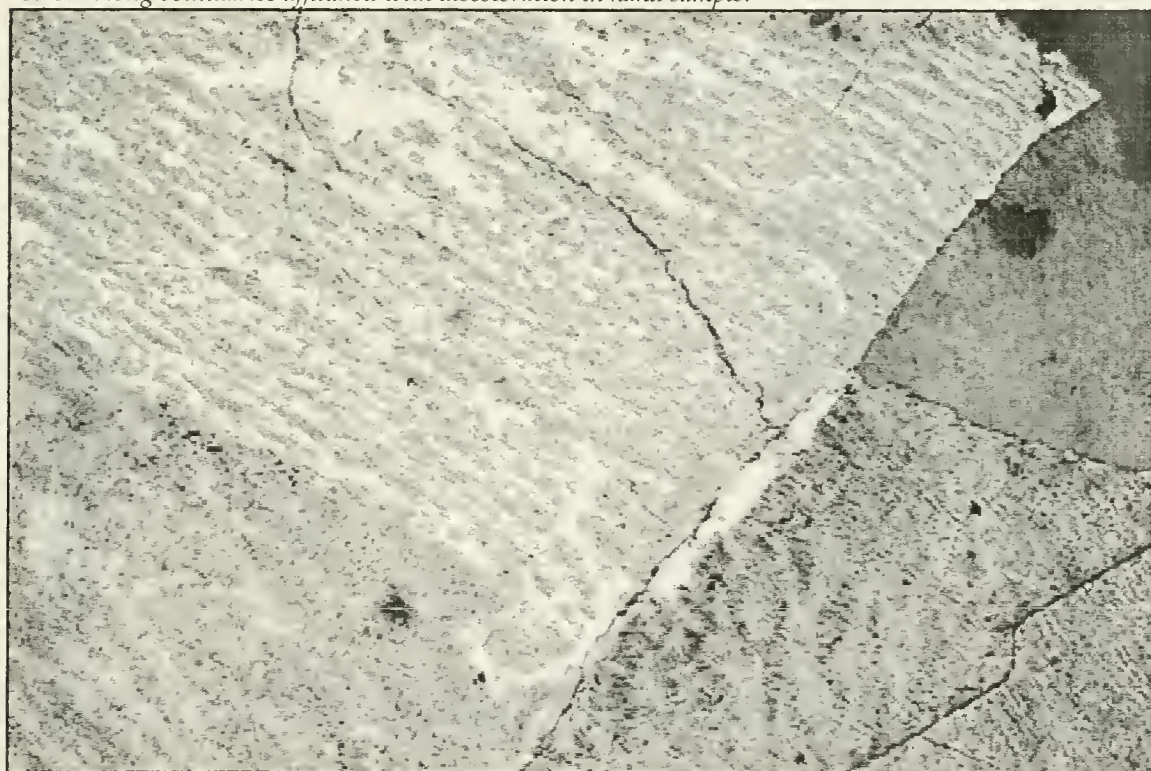
Figure 10. Sample 2, cross-polarized light, 12.5x magnification.
"Rust" along boundaries affiliated with discoloration in hand sample.

- Figure 147 (*Appendix VII, figure 10*) Granite sample 2, cross-polarized light, 12.5x magnification. "Rust" along boundaries affiliated with discoloration in hand sample.

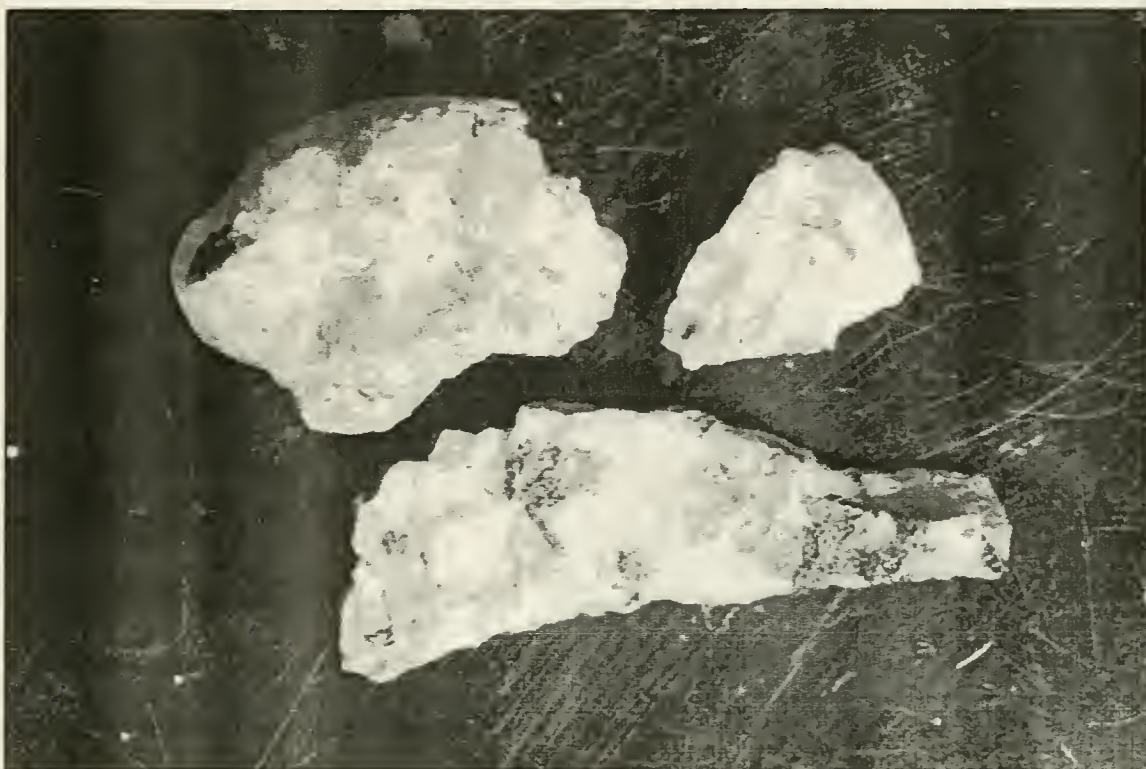
Figure 11. Sample 3, reflected light, 2.5x magnification.
Note less even-grained texture, greater quartz content, and milky white to light gray feldspar.

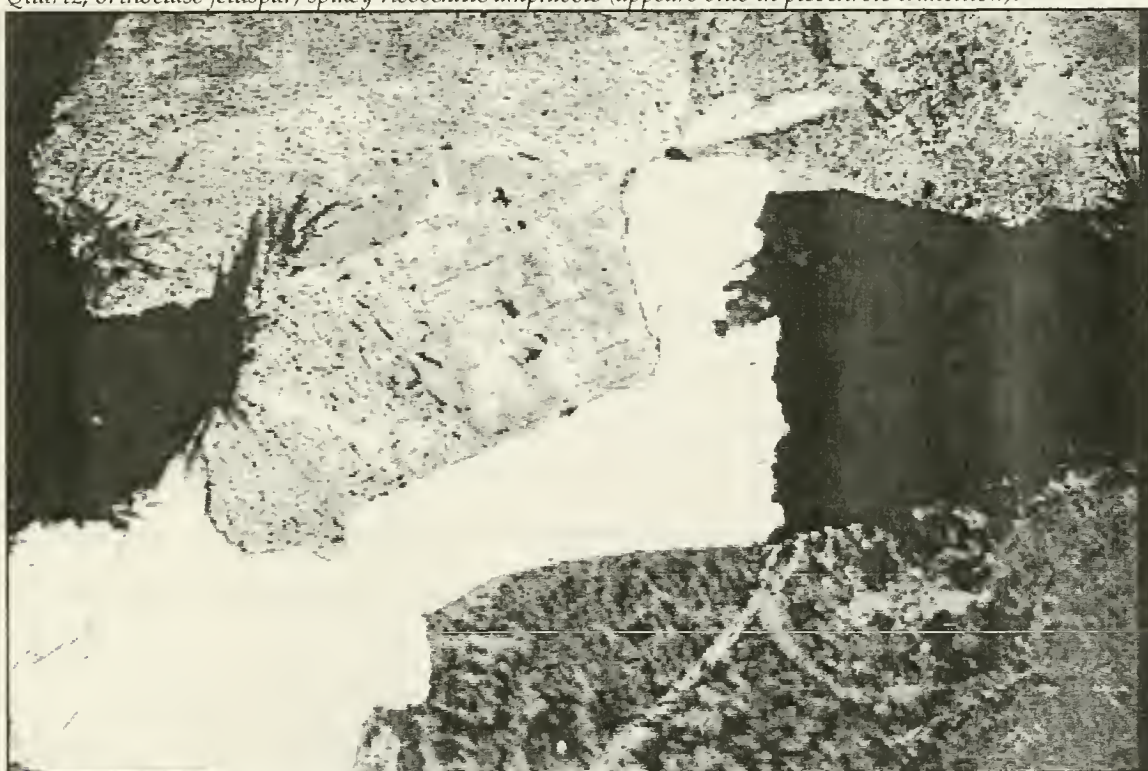
Figure 14. Sample 3, cross-polarized light, 12.5x magnification.
Quartz, orthoclase feldspar, spikey riebeckitic amphibole (appears blue in pleochroic transition above).

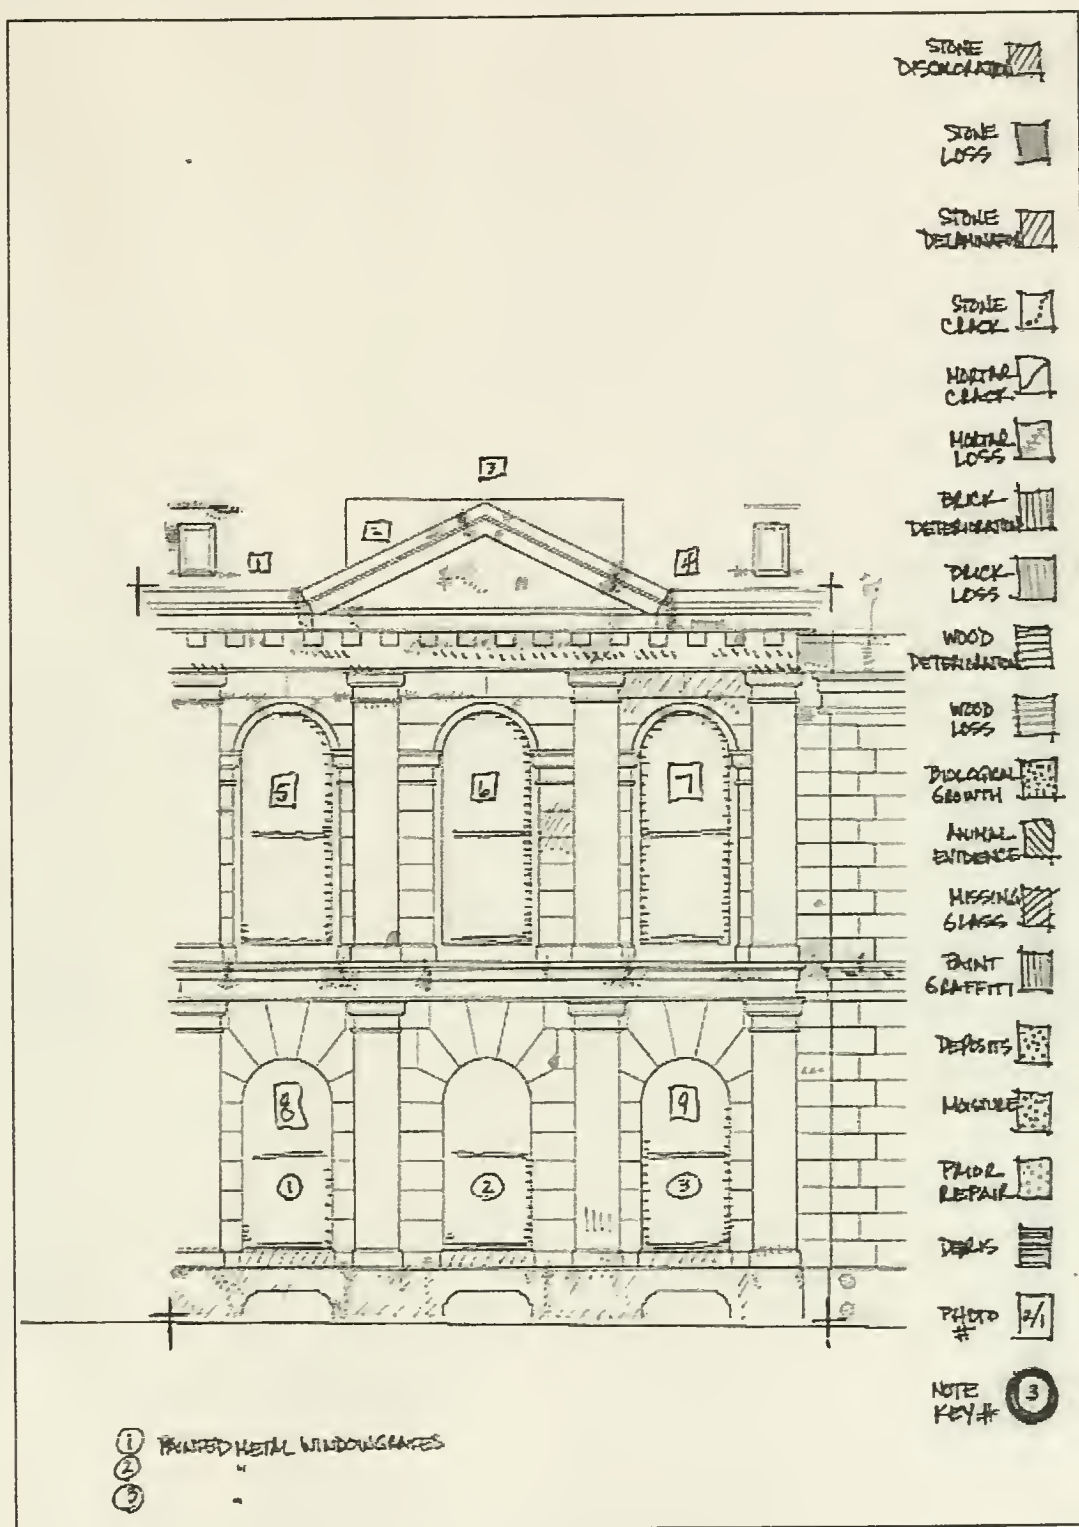
Figure 1. Condition Assessment: East façade, south section and conditions key.

- Figure 152 (*Appendix VIII, figure 1*) Condition Assessment: East façade, south section and conditions key.
- Figure 153 (*Appendix VIII, figure 2*) Condition Assessment: East façade, middle section.

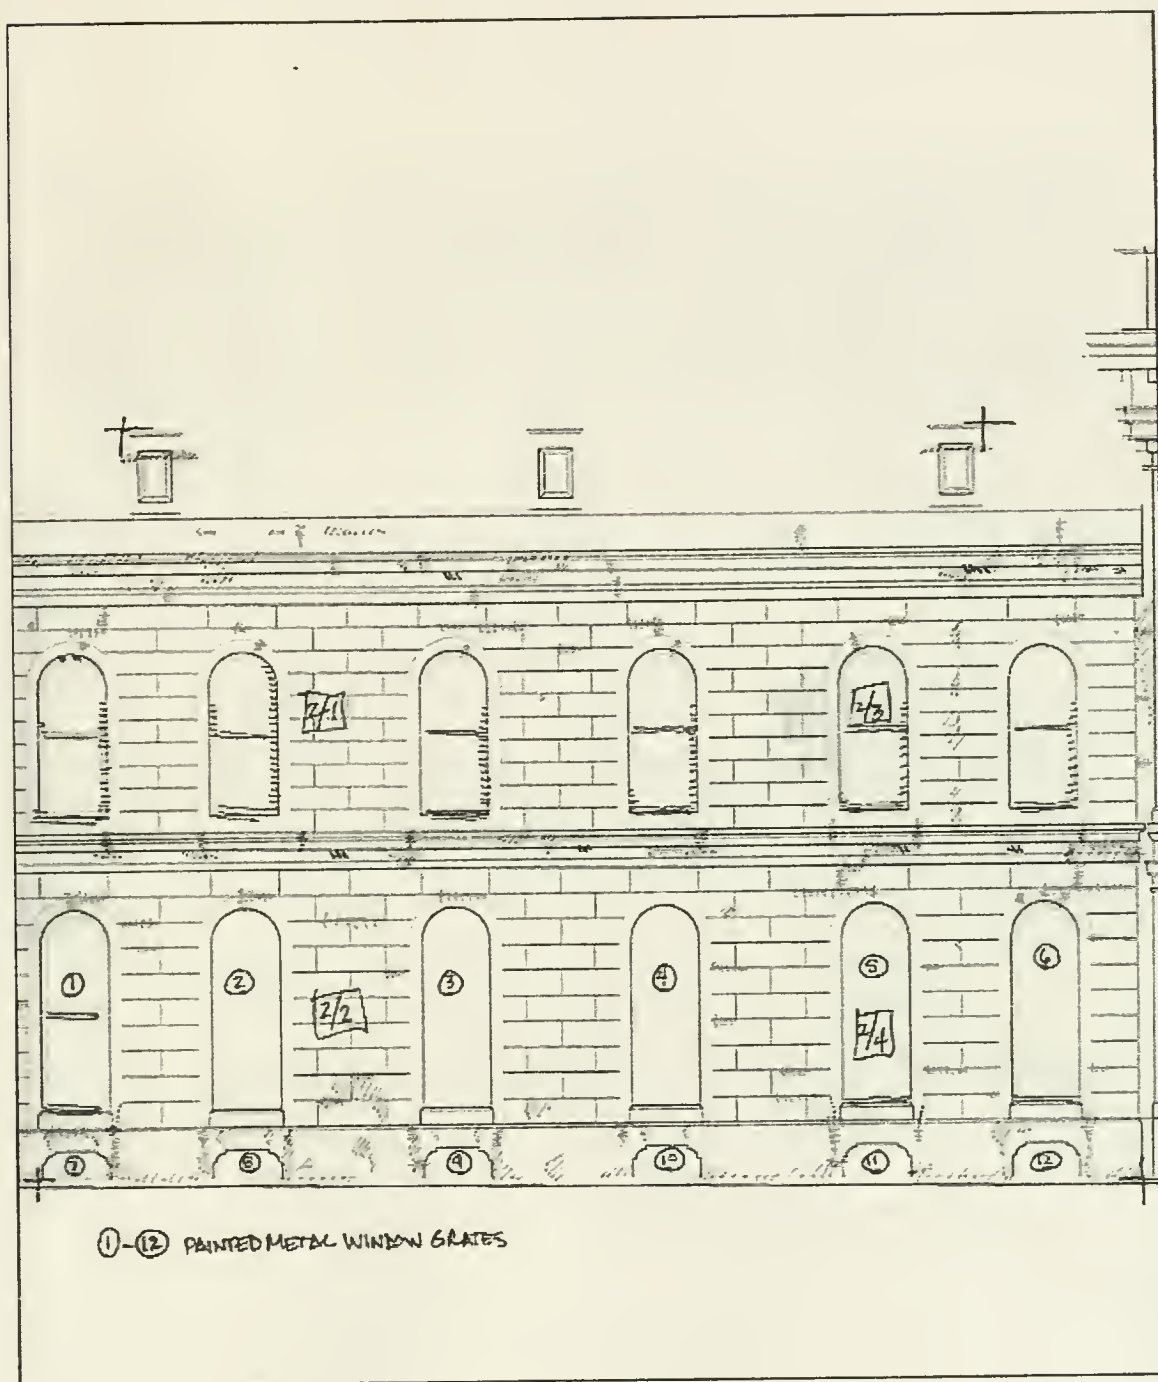
Figure 2. Condition Assessment: East façade, middle section.

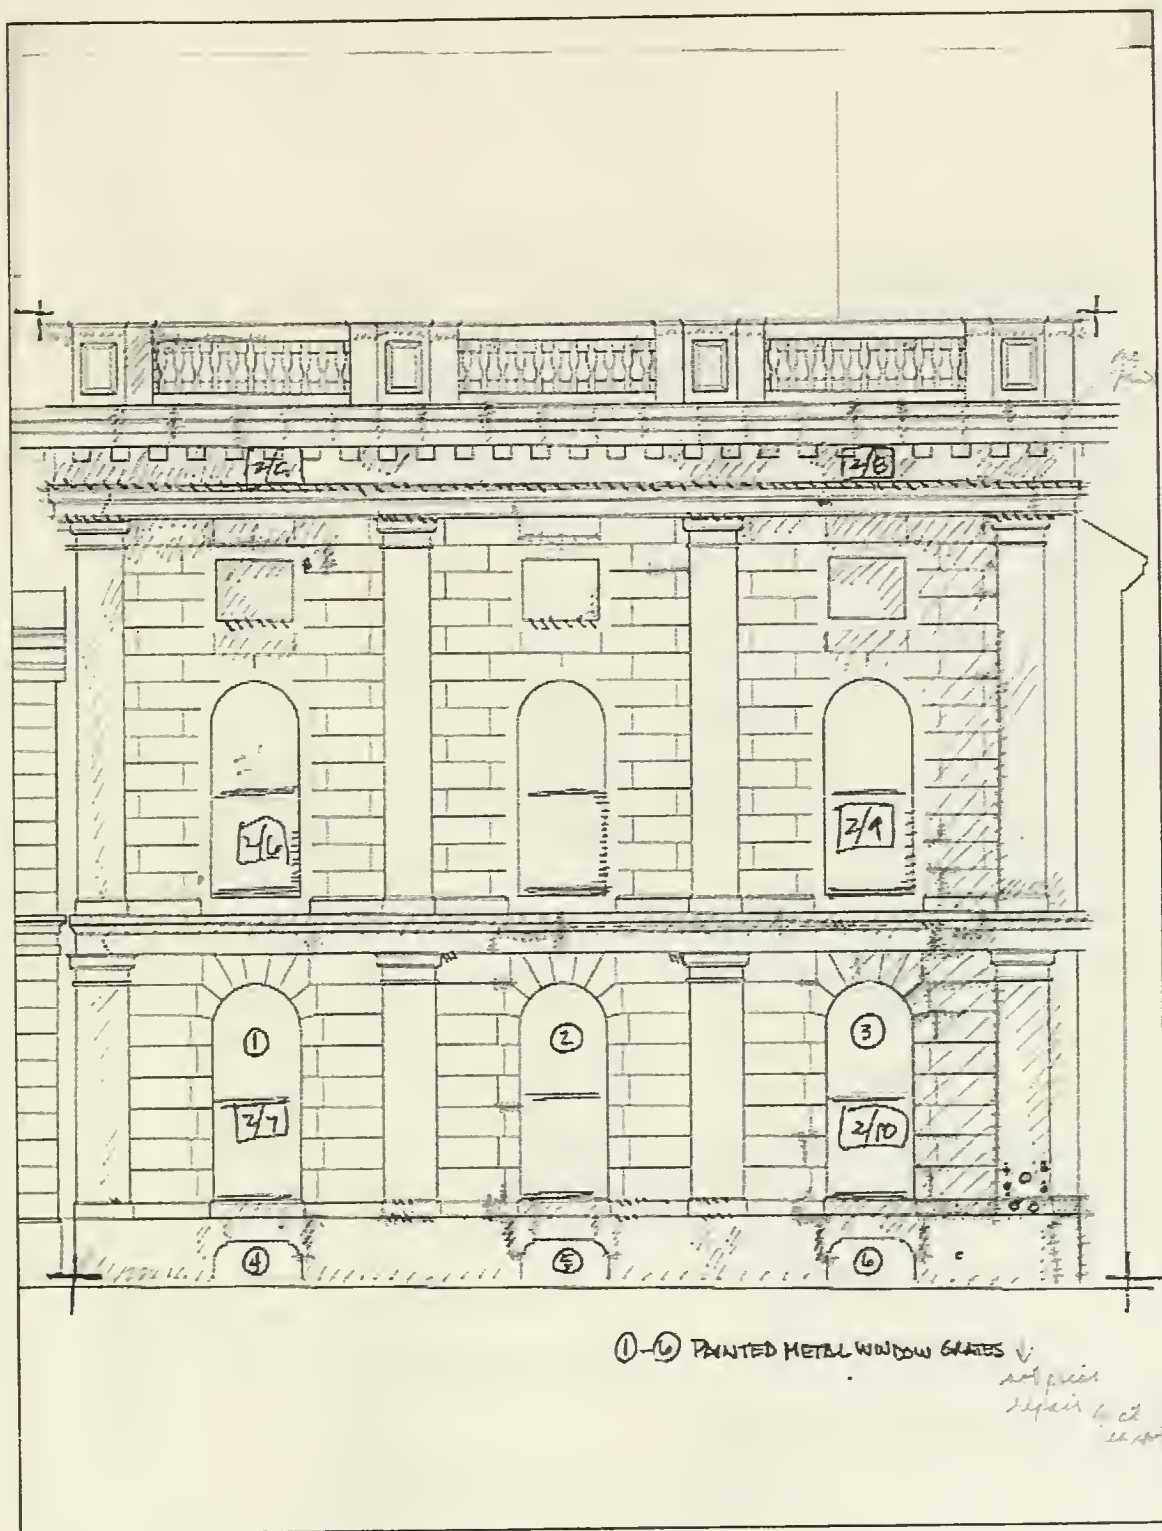
FIGURE 3. CONDITION ASSESSMENT: EAST FAÇADE, NORTH SECTION.

- Figure 154 (*Appendix VIII, figure 3*) Condition Assessment: East façade, north section.
- Figure 155 (*Appendix VIII, figure 4*) Condition Assessment: North façade, east section.

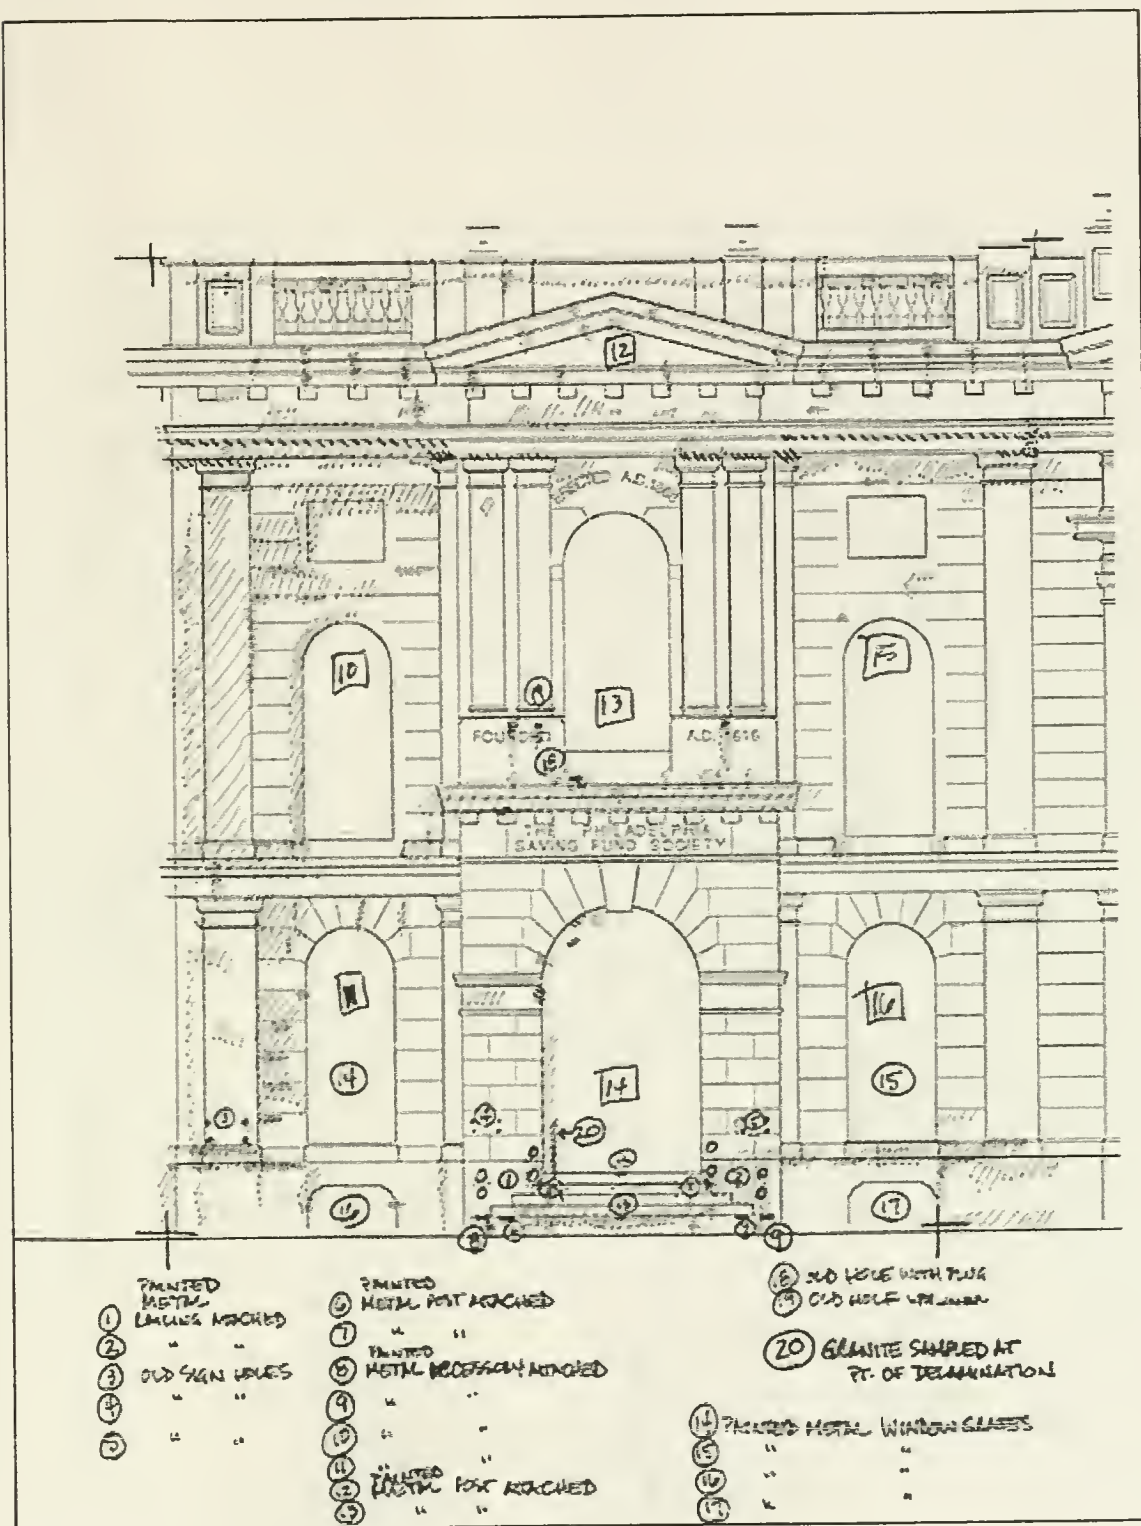
Figure 4. Condition Assessment: North façade, east section.

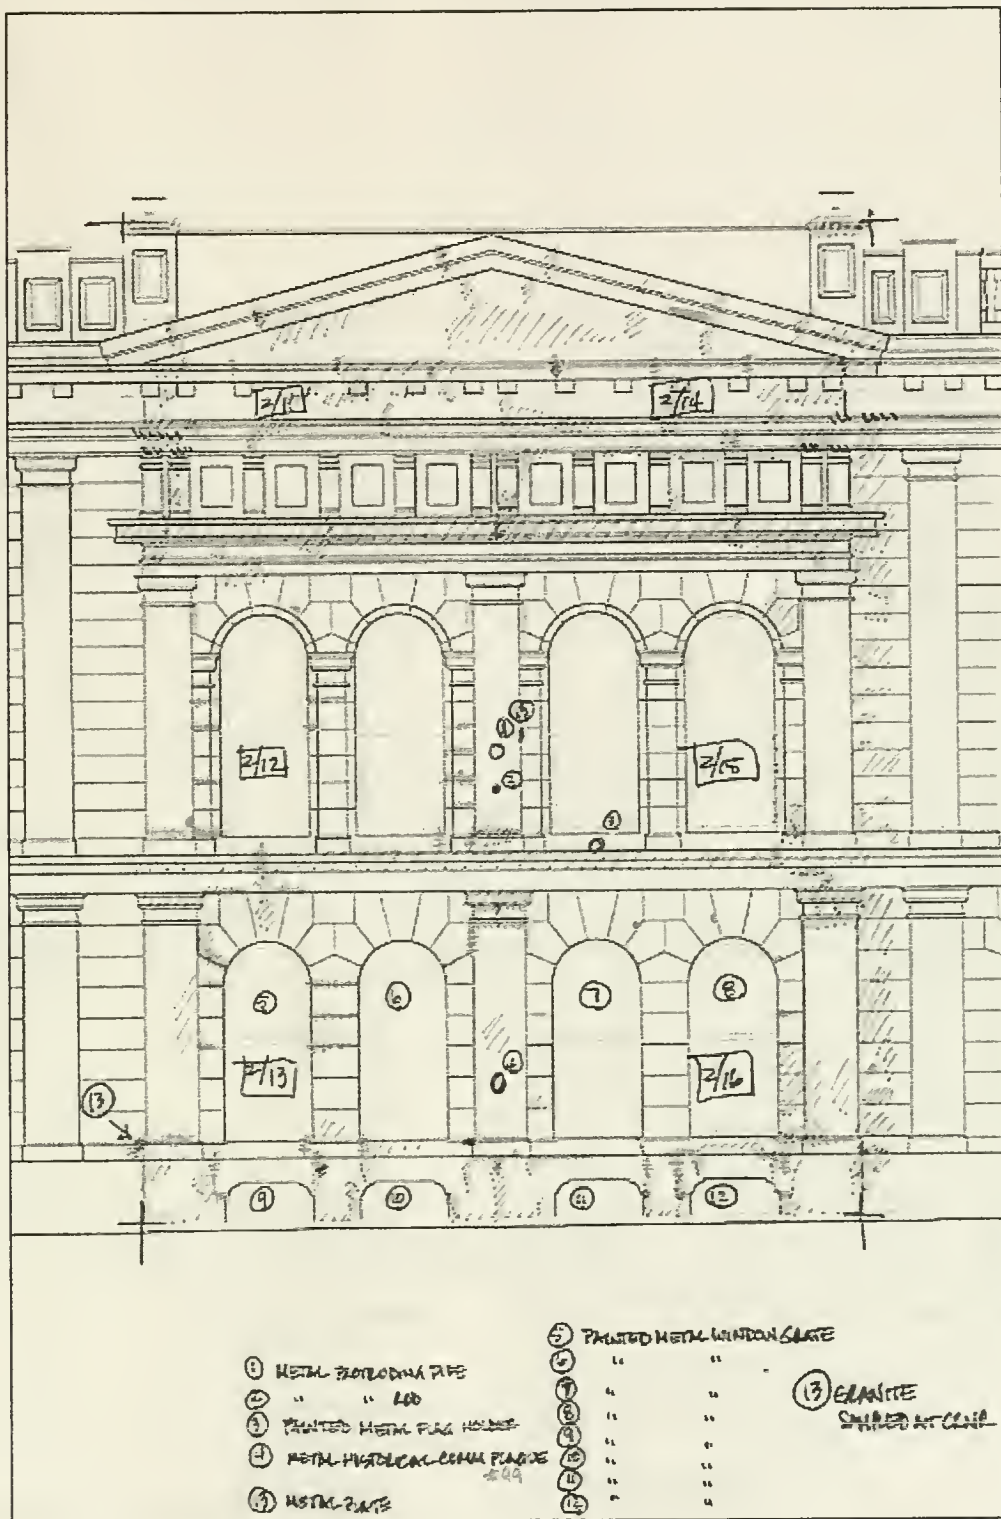
Figure 5. Condition Assessment: North façade, middle section.

- Figure 156 (*Appendix VIII, figure 5*) Condition Assessment: North façade, middle section.
- Figure 157 (*Appendix VIII, figure 6*) Condition Assessment: North façade, west section.

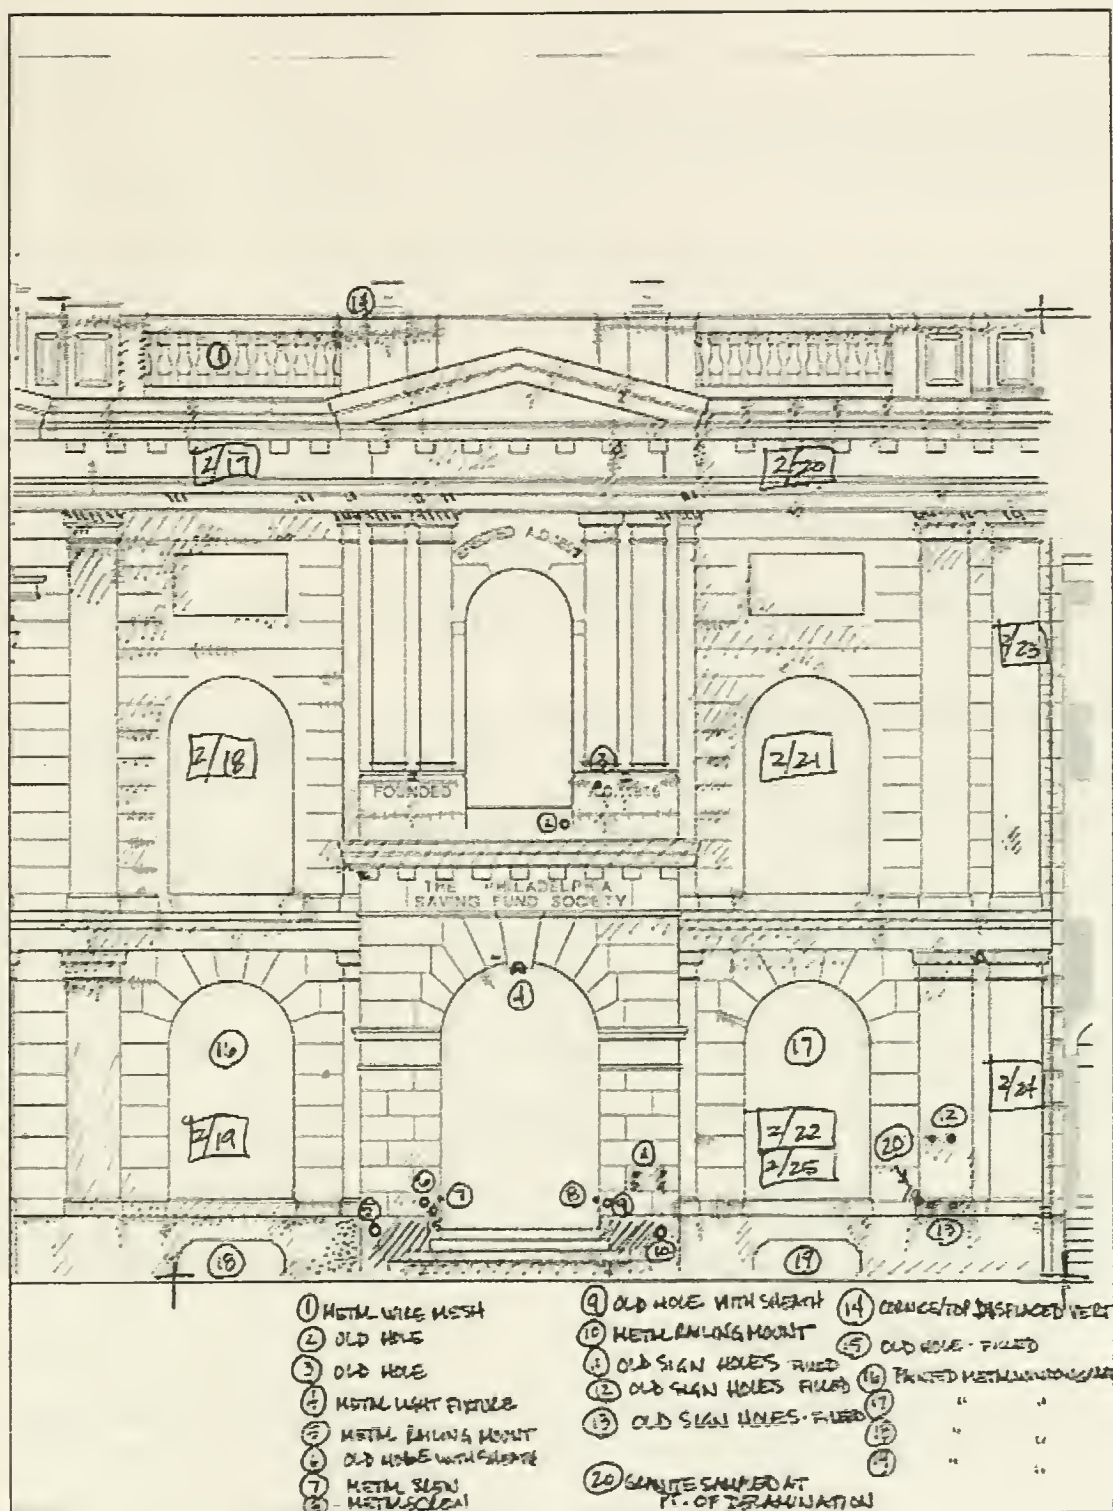
Figure 6. Condition Assessment: North façade, west section.
